## TÆRING Á RYÐFRÍU STÁLI Í ÍSLENSKU SJÁVARUMHVERFI

Áfangaskýrsla 4, niðurstöður eftir fjögur ár

02.06.2026

2970-247-SKY-009-V01

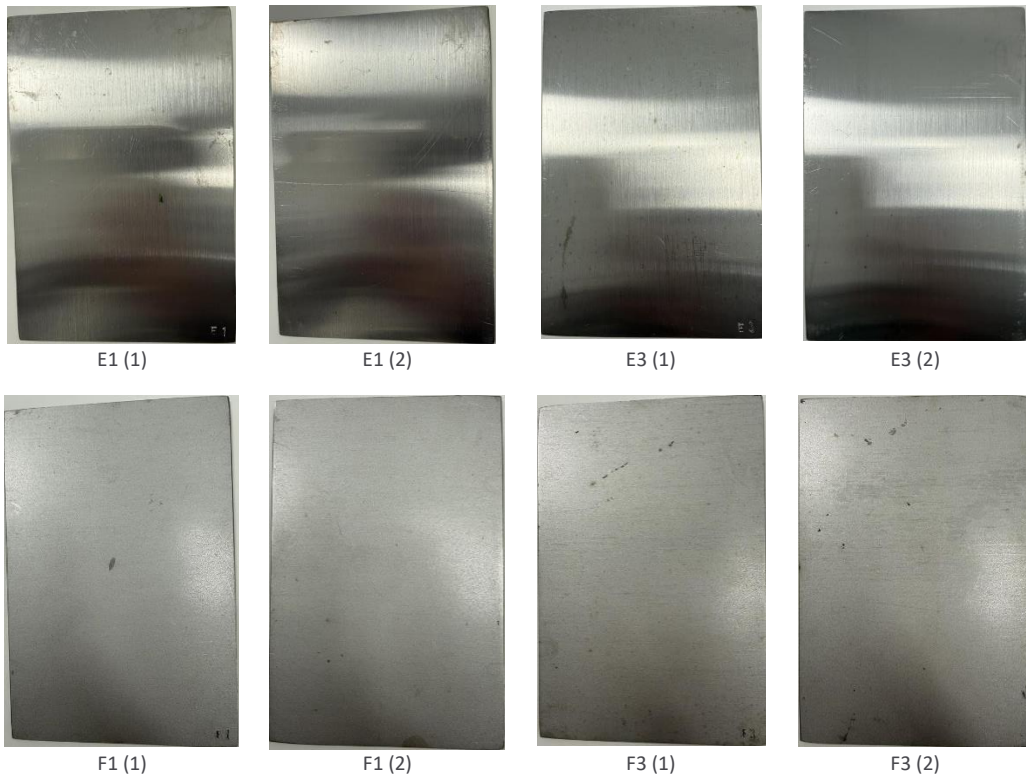
**MYND 1** Kársnes, the appearance of plate specimens after 4 years of exposure. Left: open condition, right: sheltered condition. (1) refers to front of specimen, (2) refers to back side of specimen.

| Stainless steel grade | Type of specimens | Surface finish | Result after 4 years | | | | | |
|---|---|---|---|---|---|---|---|---|
| 1.4404<br>Supra 316L | Plate | 1E | A1f | Some pits forming<br>More staining | RN6/5 | A3f | Some pits forming<br>Extended staining | RN5/3 |
| | | 1E | A1b | Corrosion spot<br>Minor staining | RN6/6 | A3b | Some pits forming<br>Extended staining | RN5/3 |

- There is little change in corrosion or staining of the samples from previous year except for steel 1.4404.
- For steel 1.4404 a difference in staining is observed between the two test sites with samples at Kársnes showing considerable more staining.
- There is more evidence of pitting in steel 1.4404 than after three years.
- There is now visible difference of samples in open air or sheltered conditions for samples of 1.4404 and other samples are showing the same trend but at a much smaller scale.
- Very little staining or corrosion was observed on any other steel samples from either test station.

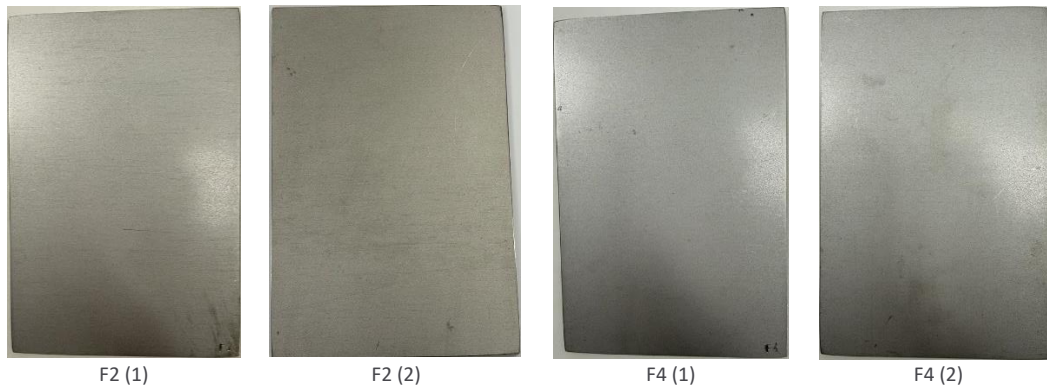
**MYND 2** Reykjavík IMO, the appearance of plate specimens after 4 years of exposure. Left: open condition, right: sheltered condition. (1) refers to front of specimen, (2) refers to back side of specimen.

| Stainless steel grade | Type of specimens | Surface finish | Result after 4 years | | | | | |
|---|---|---|---|---|---|---|---|---|
| 1.4404<br>Supra 316L | Plate | 1E | A2f | No corrosion*<br>Minor staining | RN7/7 | A4f | No corrosion*<br>Staining | RN7/4 |
| | | 1E | A2b | No corrosion*<br>Minor Staining | RN7/6 | A4b | No corrosion*<br>More staining | RN6/4 |
