**DISCUSSION SESSION ON
PERFORMANCE MODELS**

**Byron E. Ruth
University of Florida**

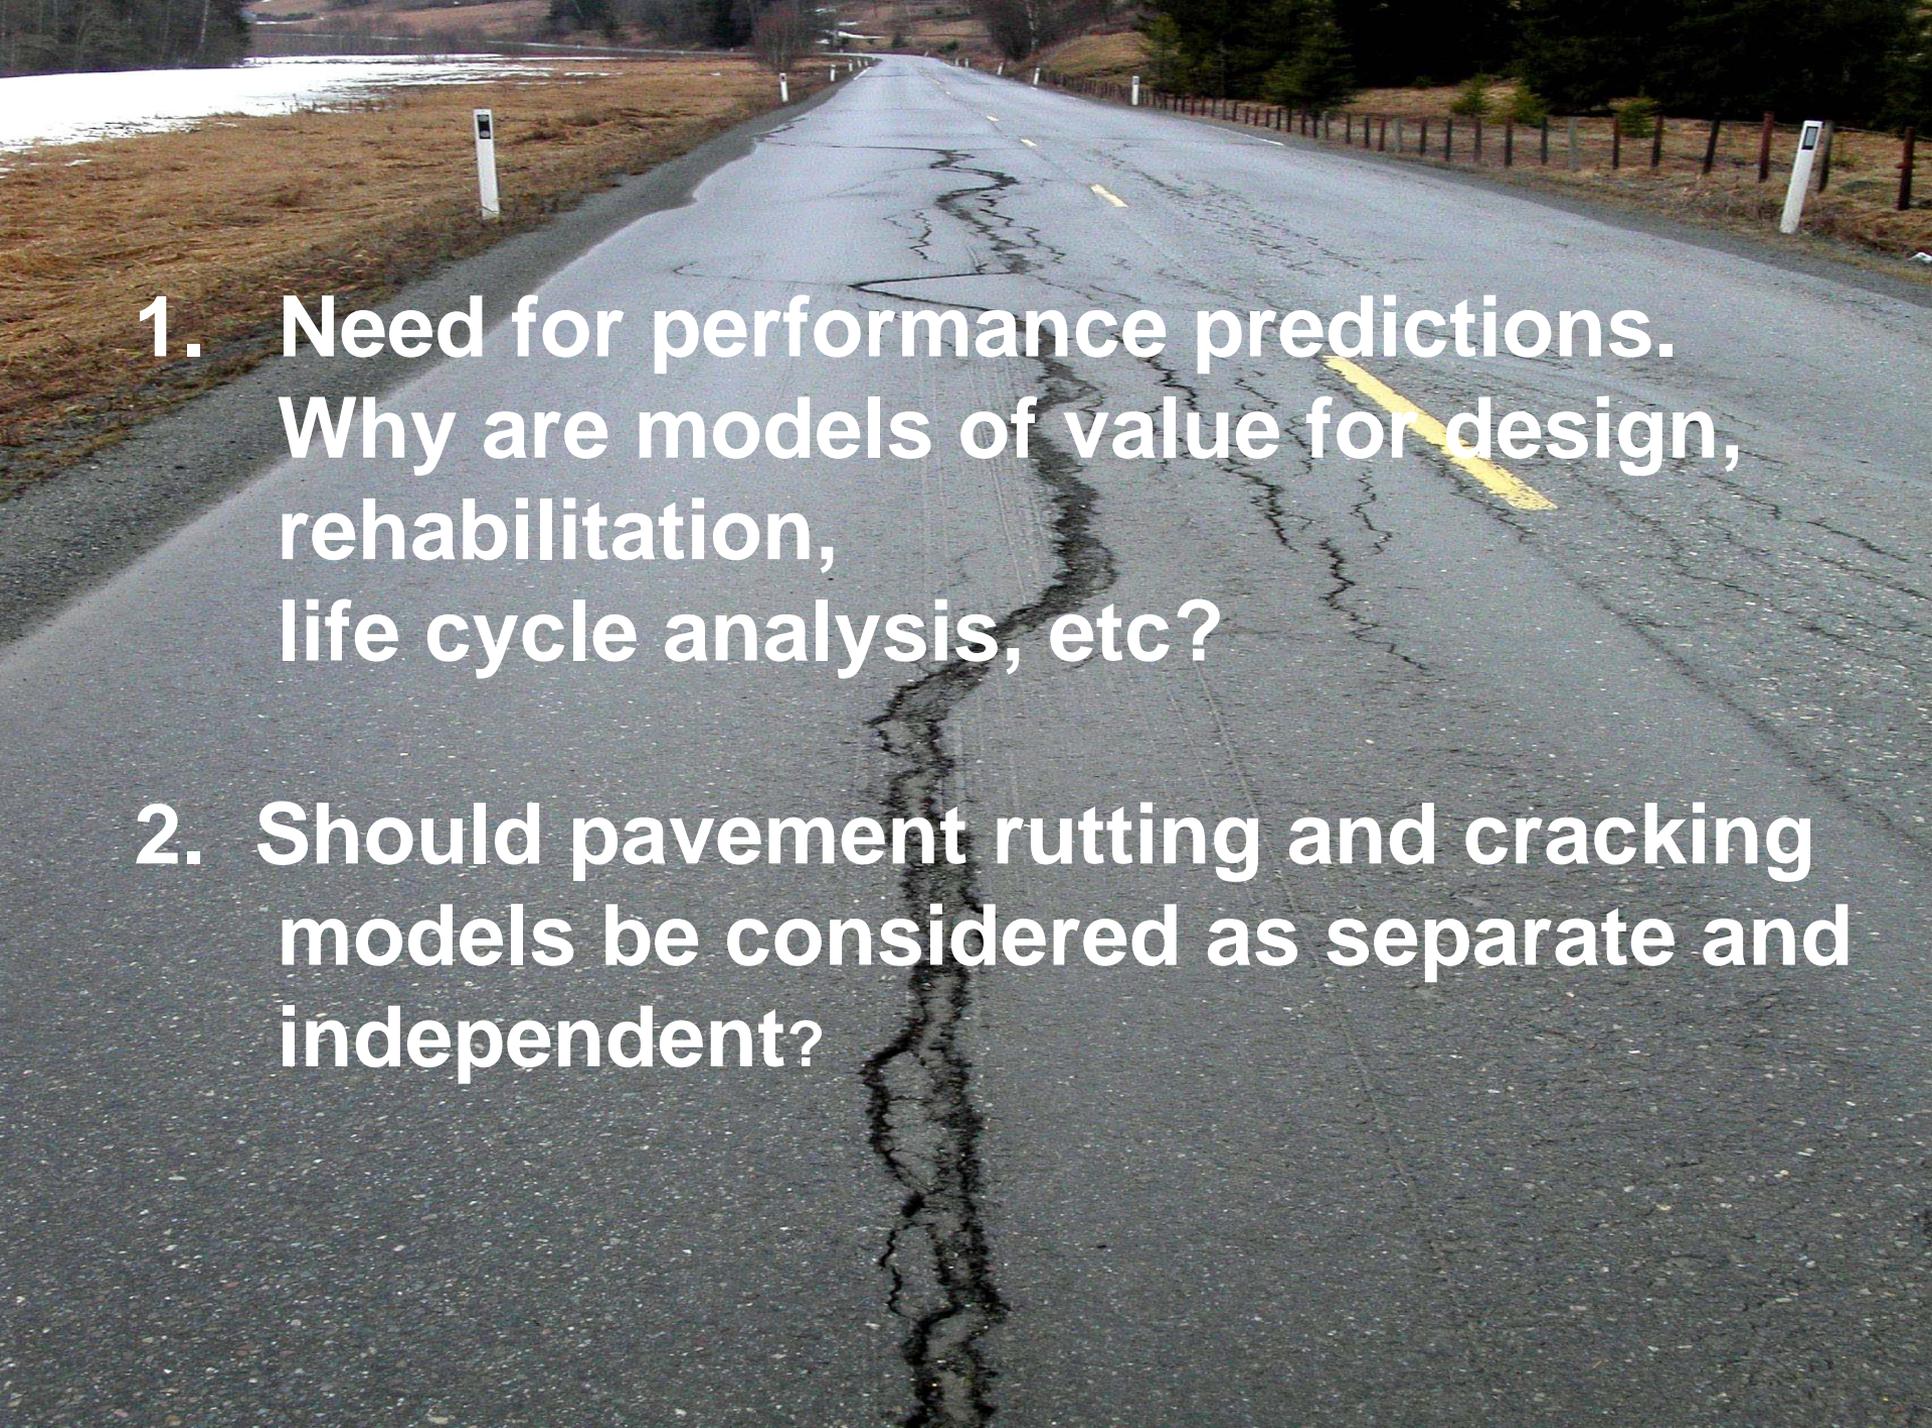
- A photograph of a two-lane asphalt road with significant cracking and rutting, illustrating the need for pavement performance models. The road is flanked by grassy areas and a fence on the right. The text is overlaid on the road surface.
- 1. Need for performance predictions. Why are models of value for design, rehabilitation, life cycle analysis, etc?**
 - 2. Should pavement rutting and cracking models be considered as separate and independent?**

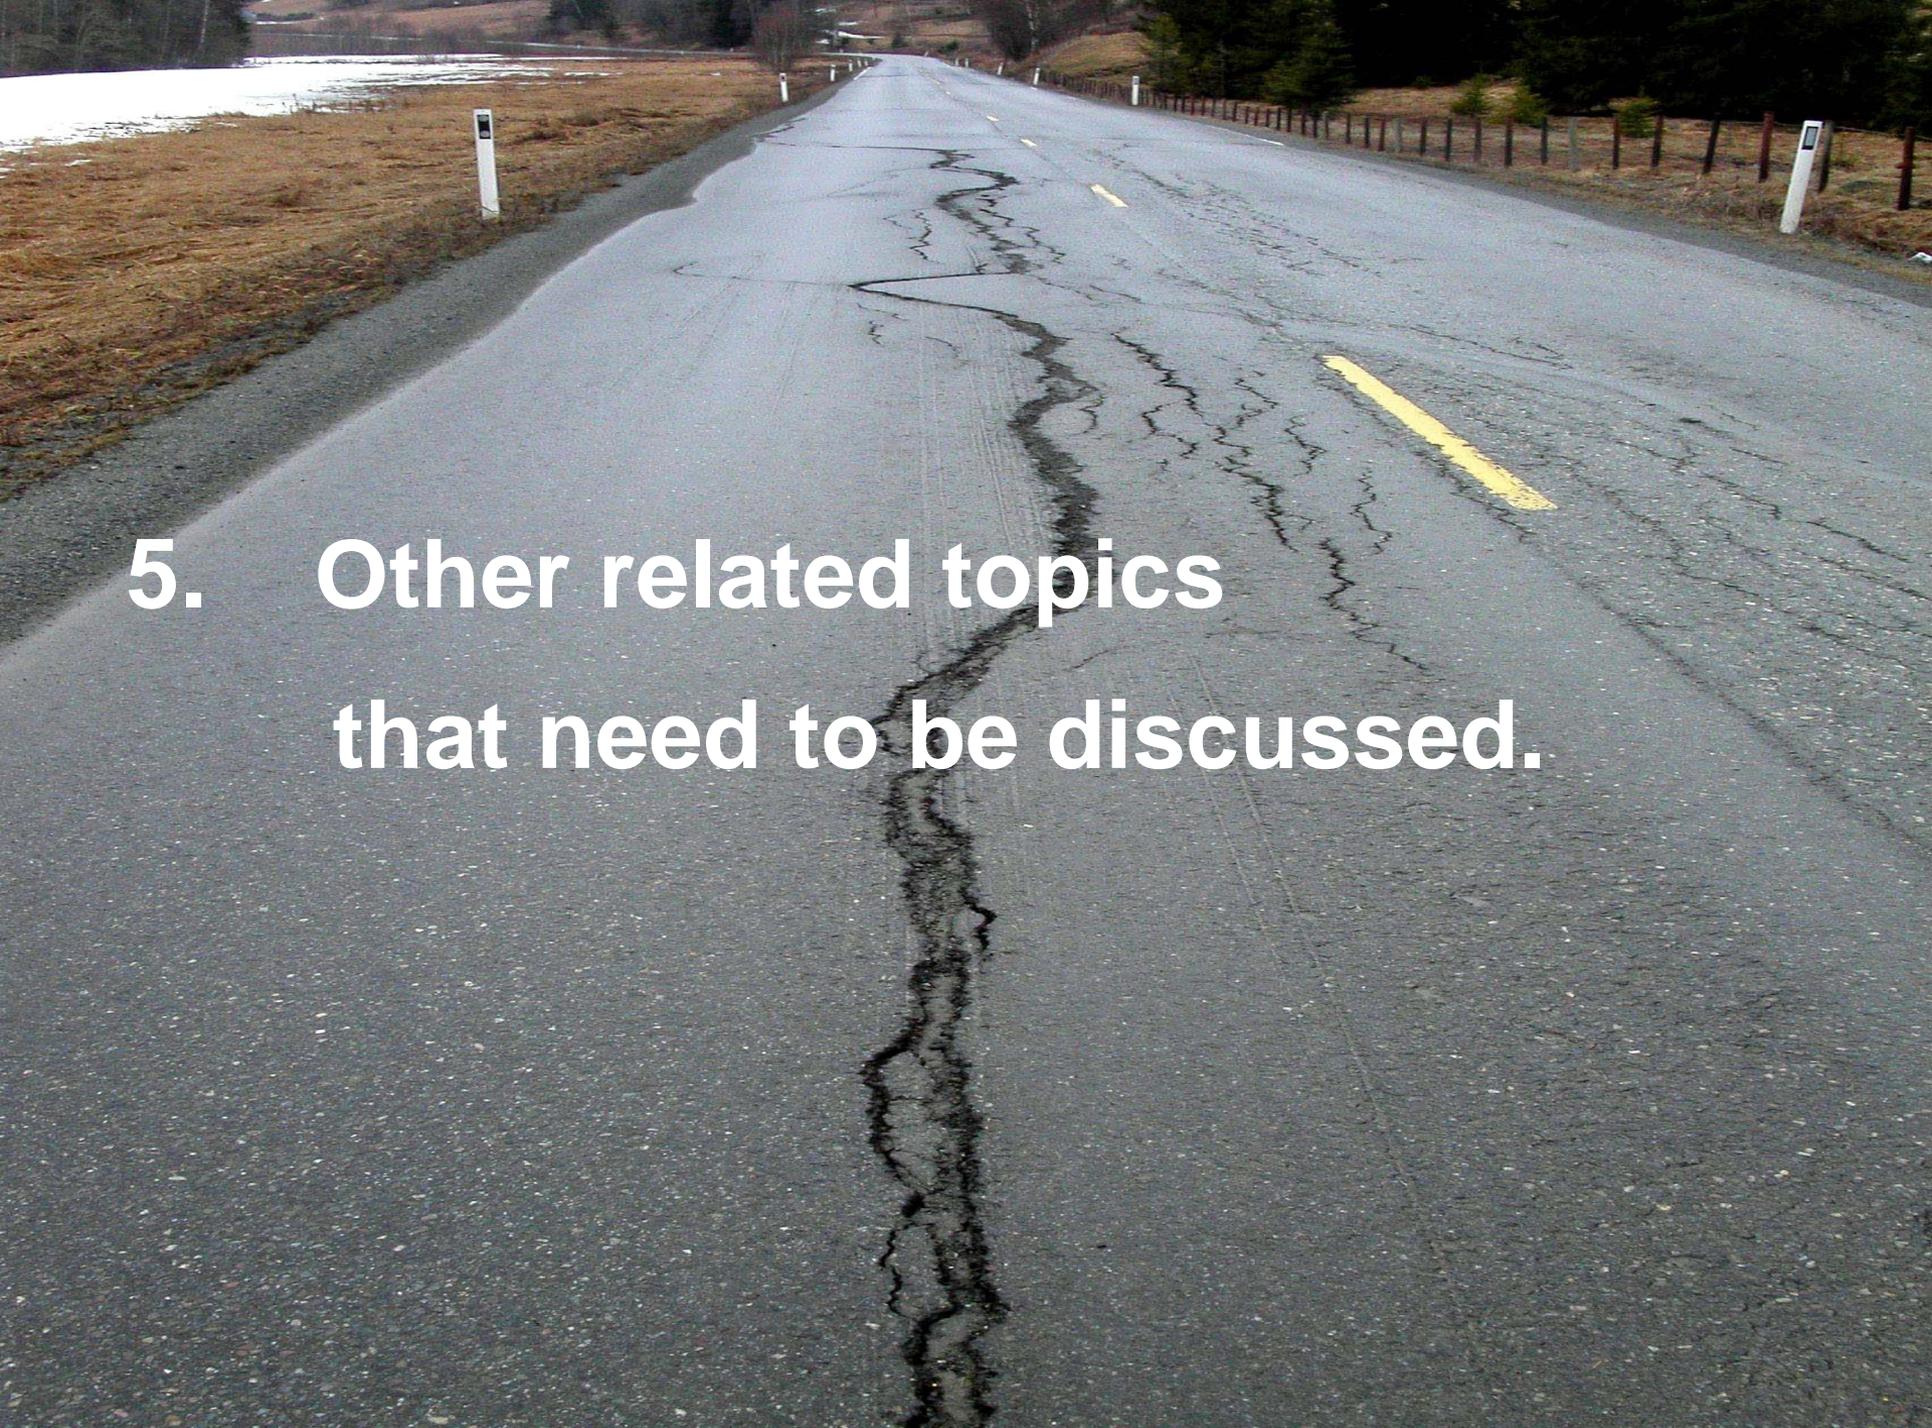
A long, straight asphalt road stretches into the distance. The road surface is heavily cracked, with a prominent longitudinal crack running down the center. A yellow dashed line is painted on the right side of the road. The road is flanked by grassy fields and trees. In the background, there is a body of water and a fence line. The overall scene is rural and somewhat desolate.
