**The 5th International Conference on
Maintenance and Rehabilitation of
Pavements and Technological Control**

***MAINTENANCE AND REHABILITATION OF LOW COST
SURFACE DRESSING FOR LOW VOLUME ROADS
– EXPERIMENTAL ROAD SITES –***

Pétur Pétursson,
Icelandic Building Research Institute
Reykjavik, Iceland
e-mail: petur.p@rabygg.is

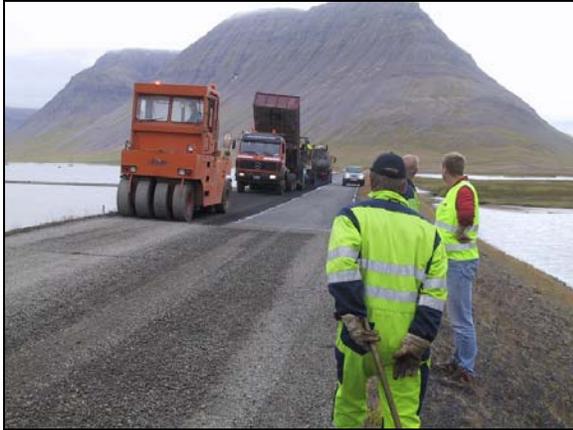
Figure 2 Laying of Vadall section

The laying process was a traditional surface dressing procedure for all test sites, see figure 2. The monitoring of the experimental road sections has been ongoing since they were laid. General description has taken place with mapping of overall conditions, close up description of aggregates, photographs and quality estimation. Figure 3 gives an example of photographs taken and figure 4 shows a typical mapping of an experimental road section

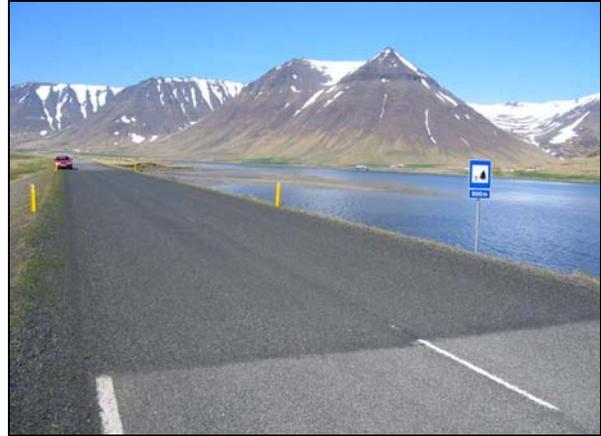
Figure3 Overview at Vadall section

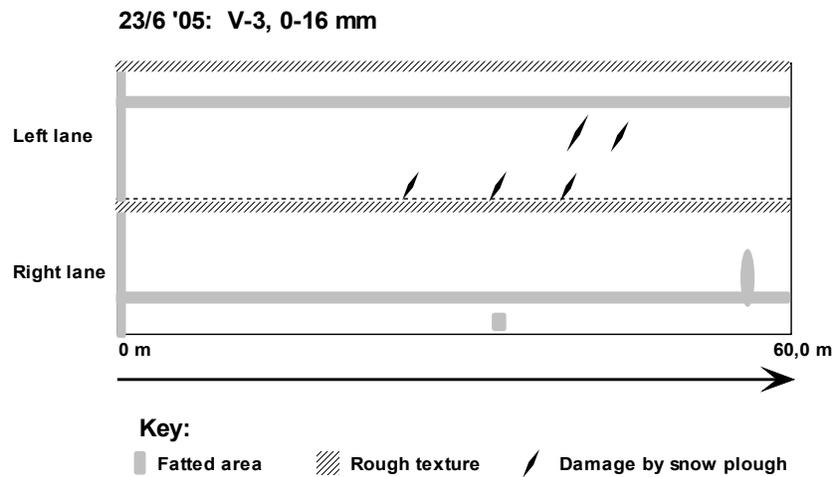
Figure 4 Example of mapping of road section
