Vulnerability assessment of Sog Bridge's lead rubber bearing pads

Evan L. Greene, Dr. Ching-Yi Tsai, Dr. Bjarni Bessason

24. Rannsóknarráðstefna Vegagerðarinnar
7. nóvember 2025

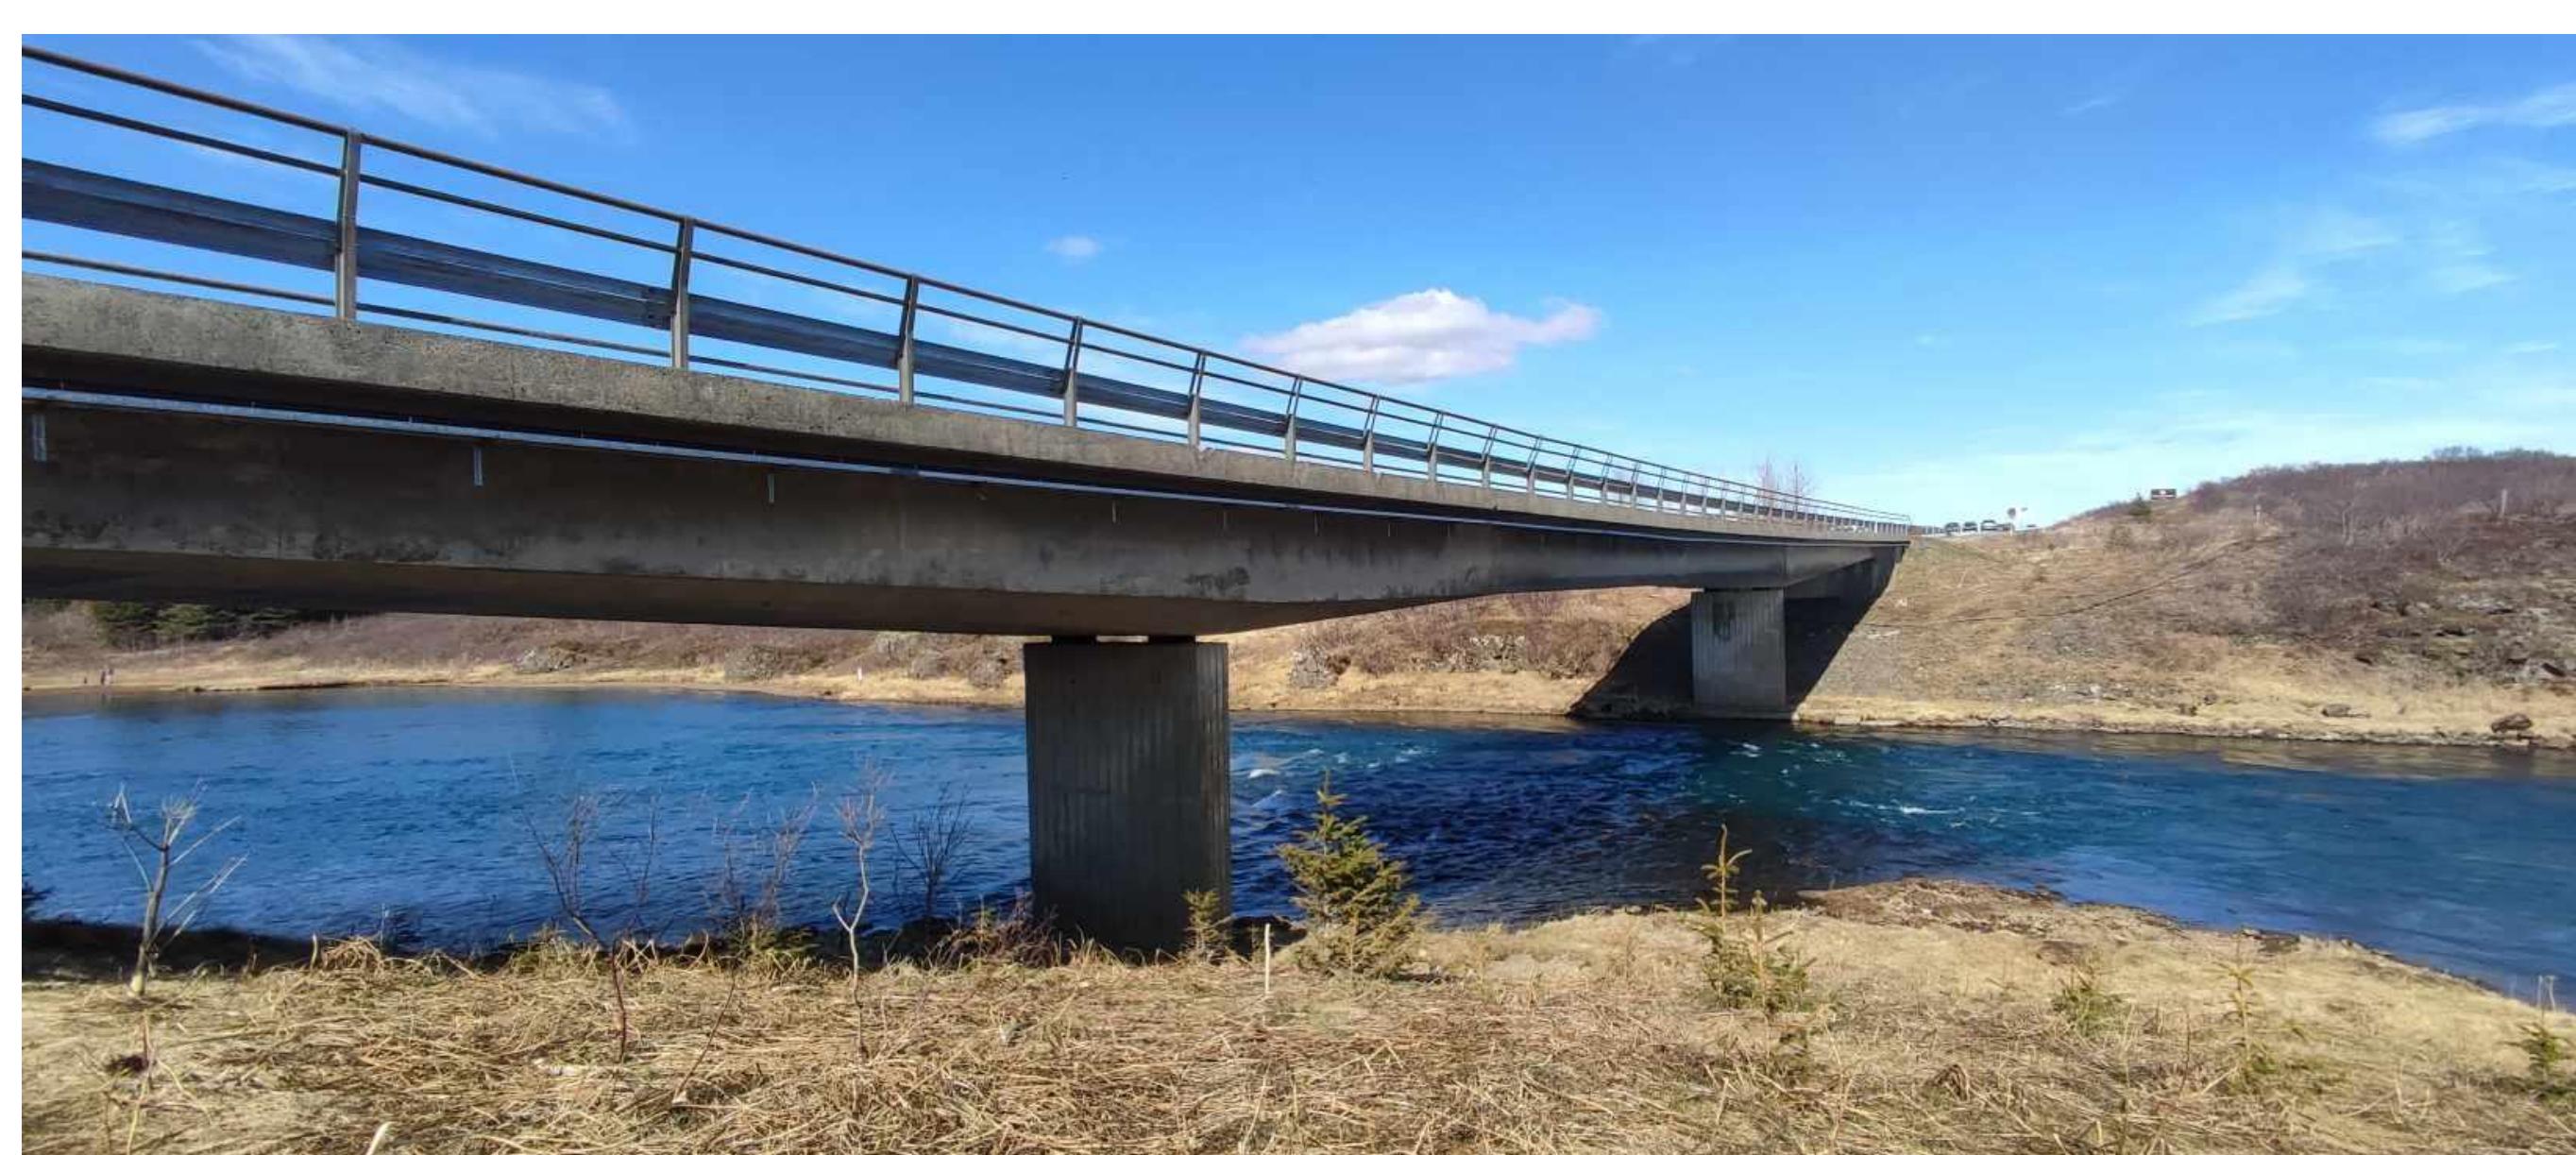
Figure 1: Sog bridge from the north-east end of the river Sog.

The Sog Bridge, constructed in 1984 (Figure 1) is a vital transit and evacuation link. It was among the first seismically isolated bridges in Iceland. The early lead rubber bearing pads were conservatively designed, resulting in a relatively small total rubber thickness and, consequently, limited flexibility compared to modern isolators. This short height affects the bridge's seismic performance. The Sog Bridge has experienced three major earthquakes (2000 and 2008). Site inspection after the May 2008 event revealed significant concrete spalling at the abutment interfaces and LRBs were permanently deformed inwards. These damages confirm substantial seismic actions at the site.
