MONITORING OF THE TJARNARDALIR LANDSLIDE, IN CENTRAL NORTH ICELAND

Th. Saemundsson¹, H.G. Petursson², C. Kneisel³ & A. Beylich⁴

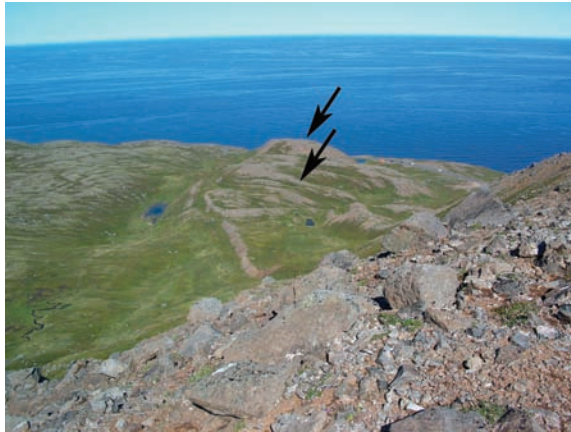
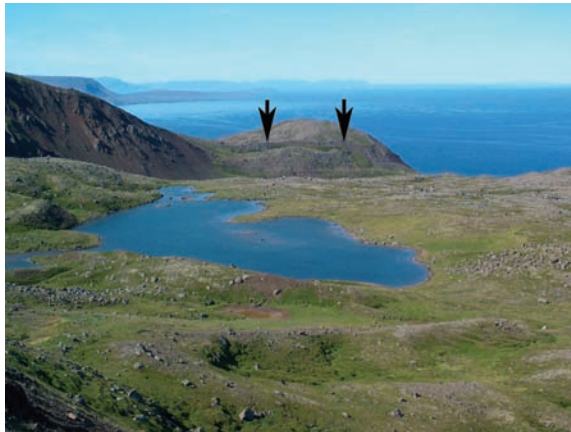
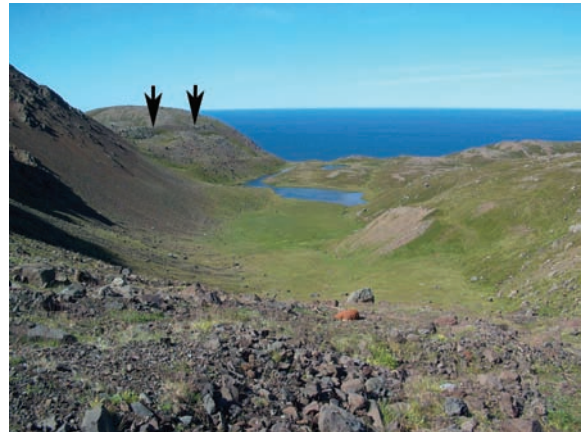
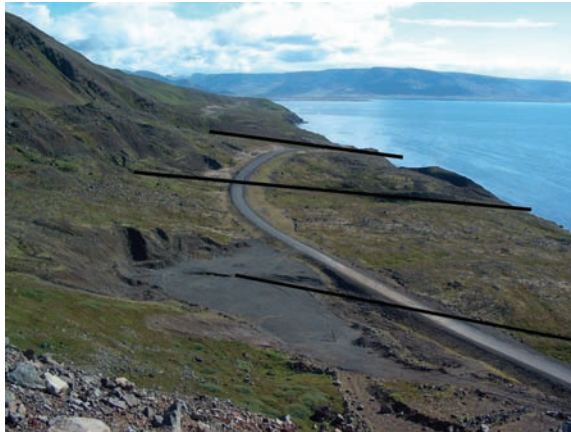
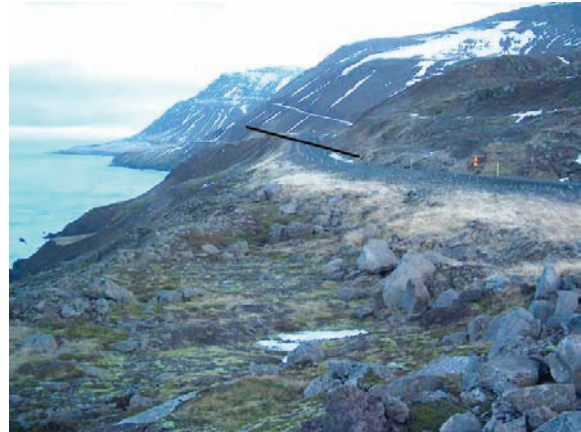
Figure 3. A: The fault zone on the northern side of the Tjarnardalir landslide. The small hill like landform on the right side of the picture (arrows) indicates the original height of the rockslide material. B: Faults and crevasses on the northern side of the landslide. C: Several small lakes and pounds occur in the uppermost part of the landslide. The small ridge-formed landforms in the slope of the Kvigildi Mountain, in the centre of the picture indicate the original height of the rockslide (arrows). D: The large depression on the southern side of the landslide, the Tjarnardalur valley. Note the small ridge like landforms in the Kvigildi Mountain, on the left side of the picture indicating the original height of the rockslide (arrows). E: The Skogar area. Note the main faults crossing the road (black lines). F: The northern part of the Tjarnardalir landslide. The road is located at 60 m a.s.l. and below there is a steep coastal cliffs and above the road a steep 30-40 m high slope is located. The black line points out one of many faults crossing the road in this area (Photos. Th. Saemundsson 2004 & 2005).

The Tjarnardalir landslide is inside an old rockslide which originally fell from the western side of the Manarfjall Mountain. The scar of the old rockslide is steep and L-shaped, ca. 800 m long from north to south and ca. 850 m long from east to west. The mean width of the sliding body is around 1400 m and mean length ca. 1550 m (figure 2). The average thickness of the debris mass is around 50 m and the total volume is estimated to be at least 110,000,000 m³. The surface of the landslide is boulder rich and characterized by streamlined landforms. Many small faults and crevasses, indicating recent movements, occur both on the surface in the middle part of the landslide and along the edges of the slide (figures 3A&B). On the northern side of the landslide a fault system can be traced from the uppermost part of the landslide down to the shoreline. North of the faults a small hill like sedimentary landform occurs, which indicates the height of the original rockslide surface (figure 3A). In the uppermost part of the landslide few small lakes and ponds occur, indicating the high groundwater level in the landslide material (figure 3C). On the southern side of the landslide a similar fault system occurs as on the northern side reaching from the headwall down to the coastline. Along this side a small valley, Tjarnardalur occurs which can be traced from the uppermost part of the slide down to the Skogar area (figure 2). This landform provides evidence of a much higher movement rate than on the northern side of the slide. A brook and several small ponds are visible on the valley floor (figures 2&3D). On the northern slope of the Kvigildi Mountain, a ridge like landforms occurs, indicating the original height of the rockslide surface, as on the northern side (figures 3C&D).

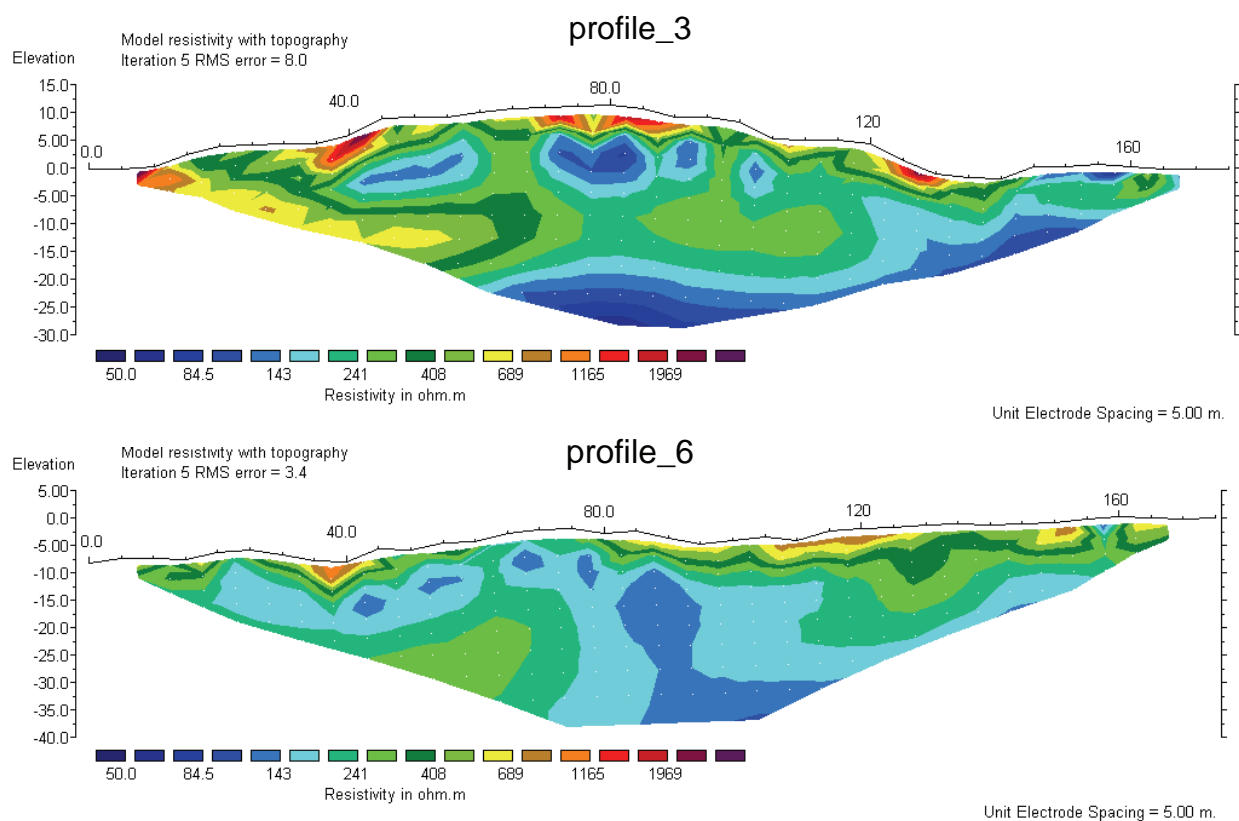
Figure 5. Examples from the electrical resistivity survey in the Tjarnardalir landslide. The locations of the profiles are shown on figure 2. Profile 3 is orientated N – S (left to right) and profile 6 from E – W. Legend: Yellow and red colors = higher resistivity / drier condition. Green and blue colors = lower resistivity / wetter condition.

The results of these measurements indicate that all profiles show a rather good conductivity in the subsurface, partly due to the very high soil moisture, as indicated by the low resistivity values (<150 ohm.m). The near-surface material is in some cases markedly drier (higher resistivities, yellow and red colors). Most of the images of resistivities against depth show a general decrease in resistivity with depth with some moist parts and variability of the resistivities at shallow depth or show a more or less overall high conductivity due to high moisture content. From the range of resistivities, it can only be concluded that the subsurface consists of landslide debris with different grain sizes leading to variable moisture contents and thus conductivity.

According to the resistivity survey high moisture content occur in the debris mass in the Tjarnardalir landslide. No real stratification of the sediments or differentiation of material/grain size was possible from the geoelectrics survey alone and the survey did not give any clear signal that the bedrock was reached.
