## TÆRING Á RYÐFRÍU STÁLI Í ÍSLENSKU SJÁVARUMHVERFI

Áfangaskýrsla 4, niðurstöður eftir fjögur ár

02.06.2026

2970-247-SKY-009-V01

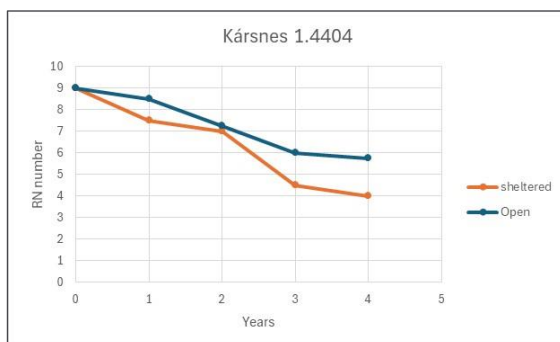
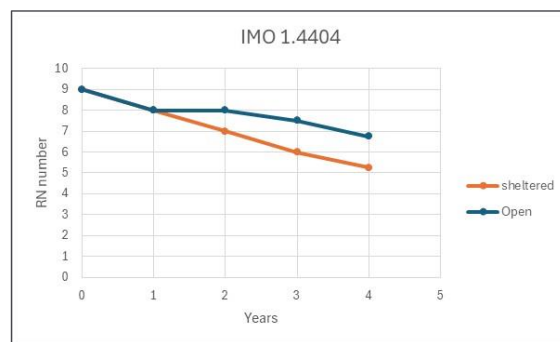
- There is little change in corrosion or staining of the samples from previous year except for steel 1.4404.
- For steel 1.4404 a difference in staining is observed between the two test sites with samples at Kársnes showing considerable more staining.
- There is more evidence of pitting in steel 1.4404 than after three years.
- There is now visible difference of samples in open air or sheltered conditions for samples of 1.4404 and other samples are showing the same trend but at a much smaller scale.
- Very little staining or corrosion was observed on any other steel samples from either test station.

The only stainless steel to give any results that are possible to represent grafically is 1.4404. The RN rating is taken to be the average of the score of two independent observers og both sides of the specimens; i.e. of four numbers.
