# Pavement performance prediction models in Finland

Taina Rantanen

Sito Finnish Consulting Engineering

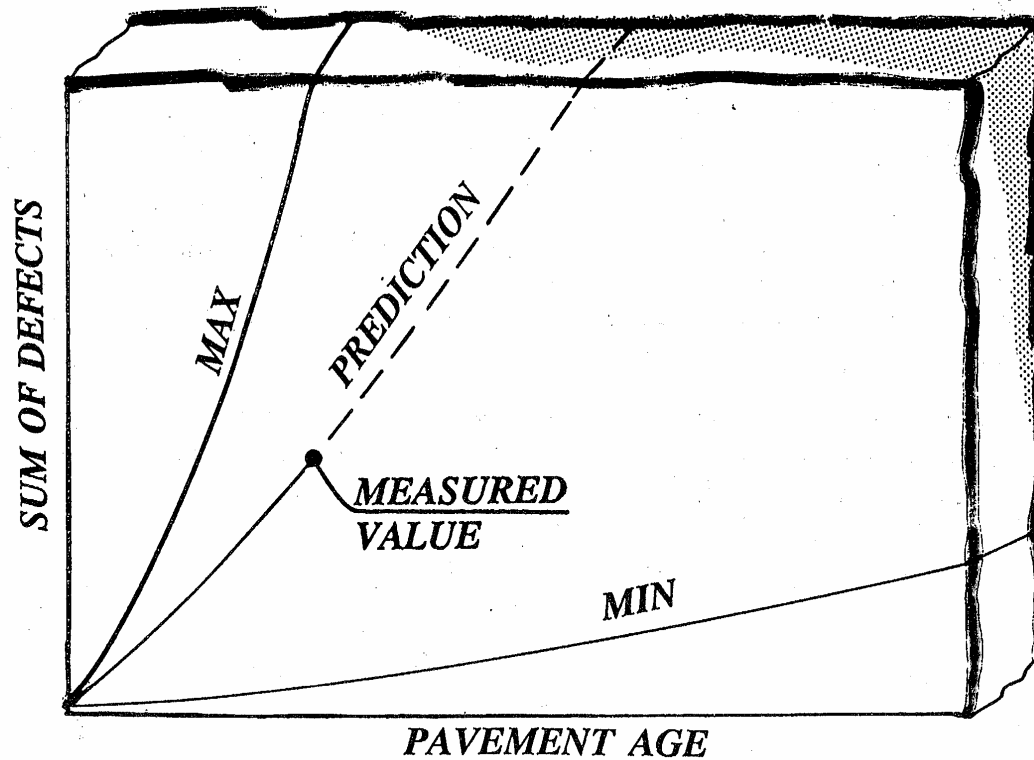
# Principle of predicting the change in the sum of defects (Road Condition Measurements and Pavement design in Finland, 1993)

SUM OF DEFECTS = RATE \* TIME<sup>N</sup>

RATE = (MEASURED VALUE)/(PAVEMENT AGE)<sup>N</sup>

N = VARIABLE, DEFAULT VALUE FOR ASPHALT CONCRETE IS 1.6

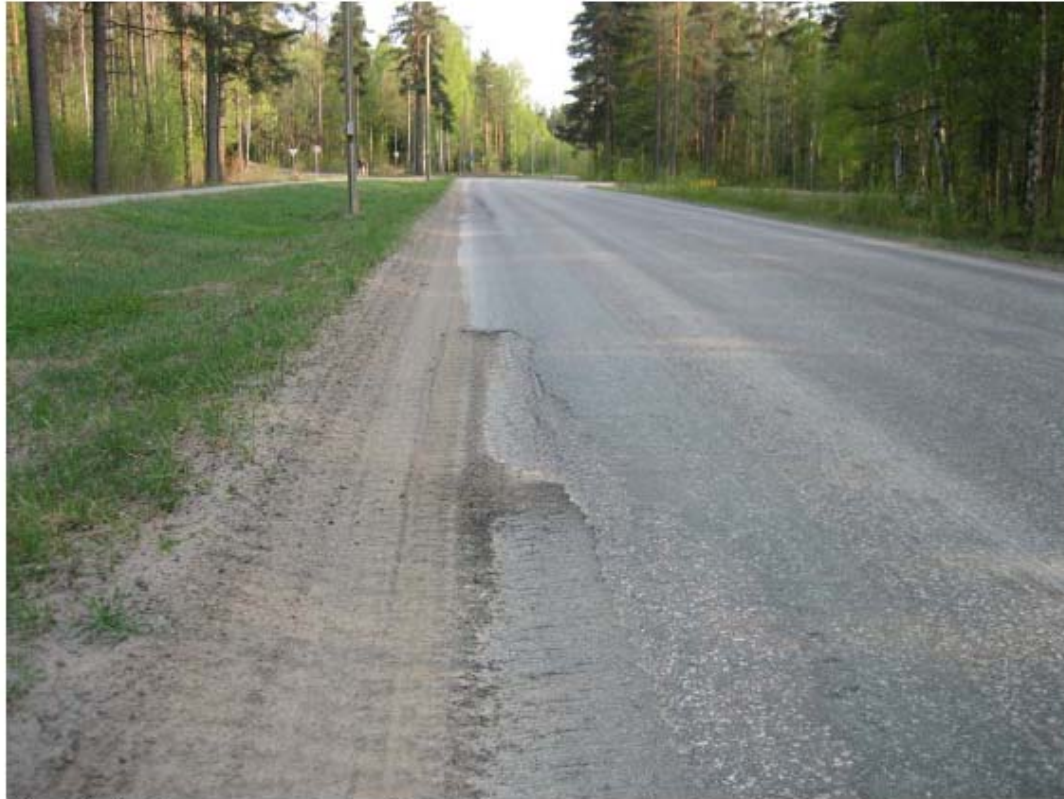
Kuva 3. Päällyste on murtunut tien reunasta.

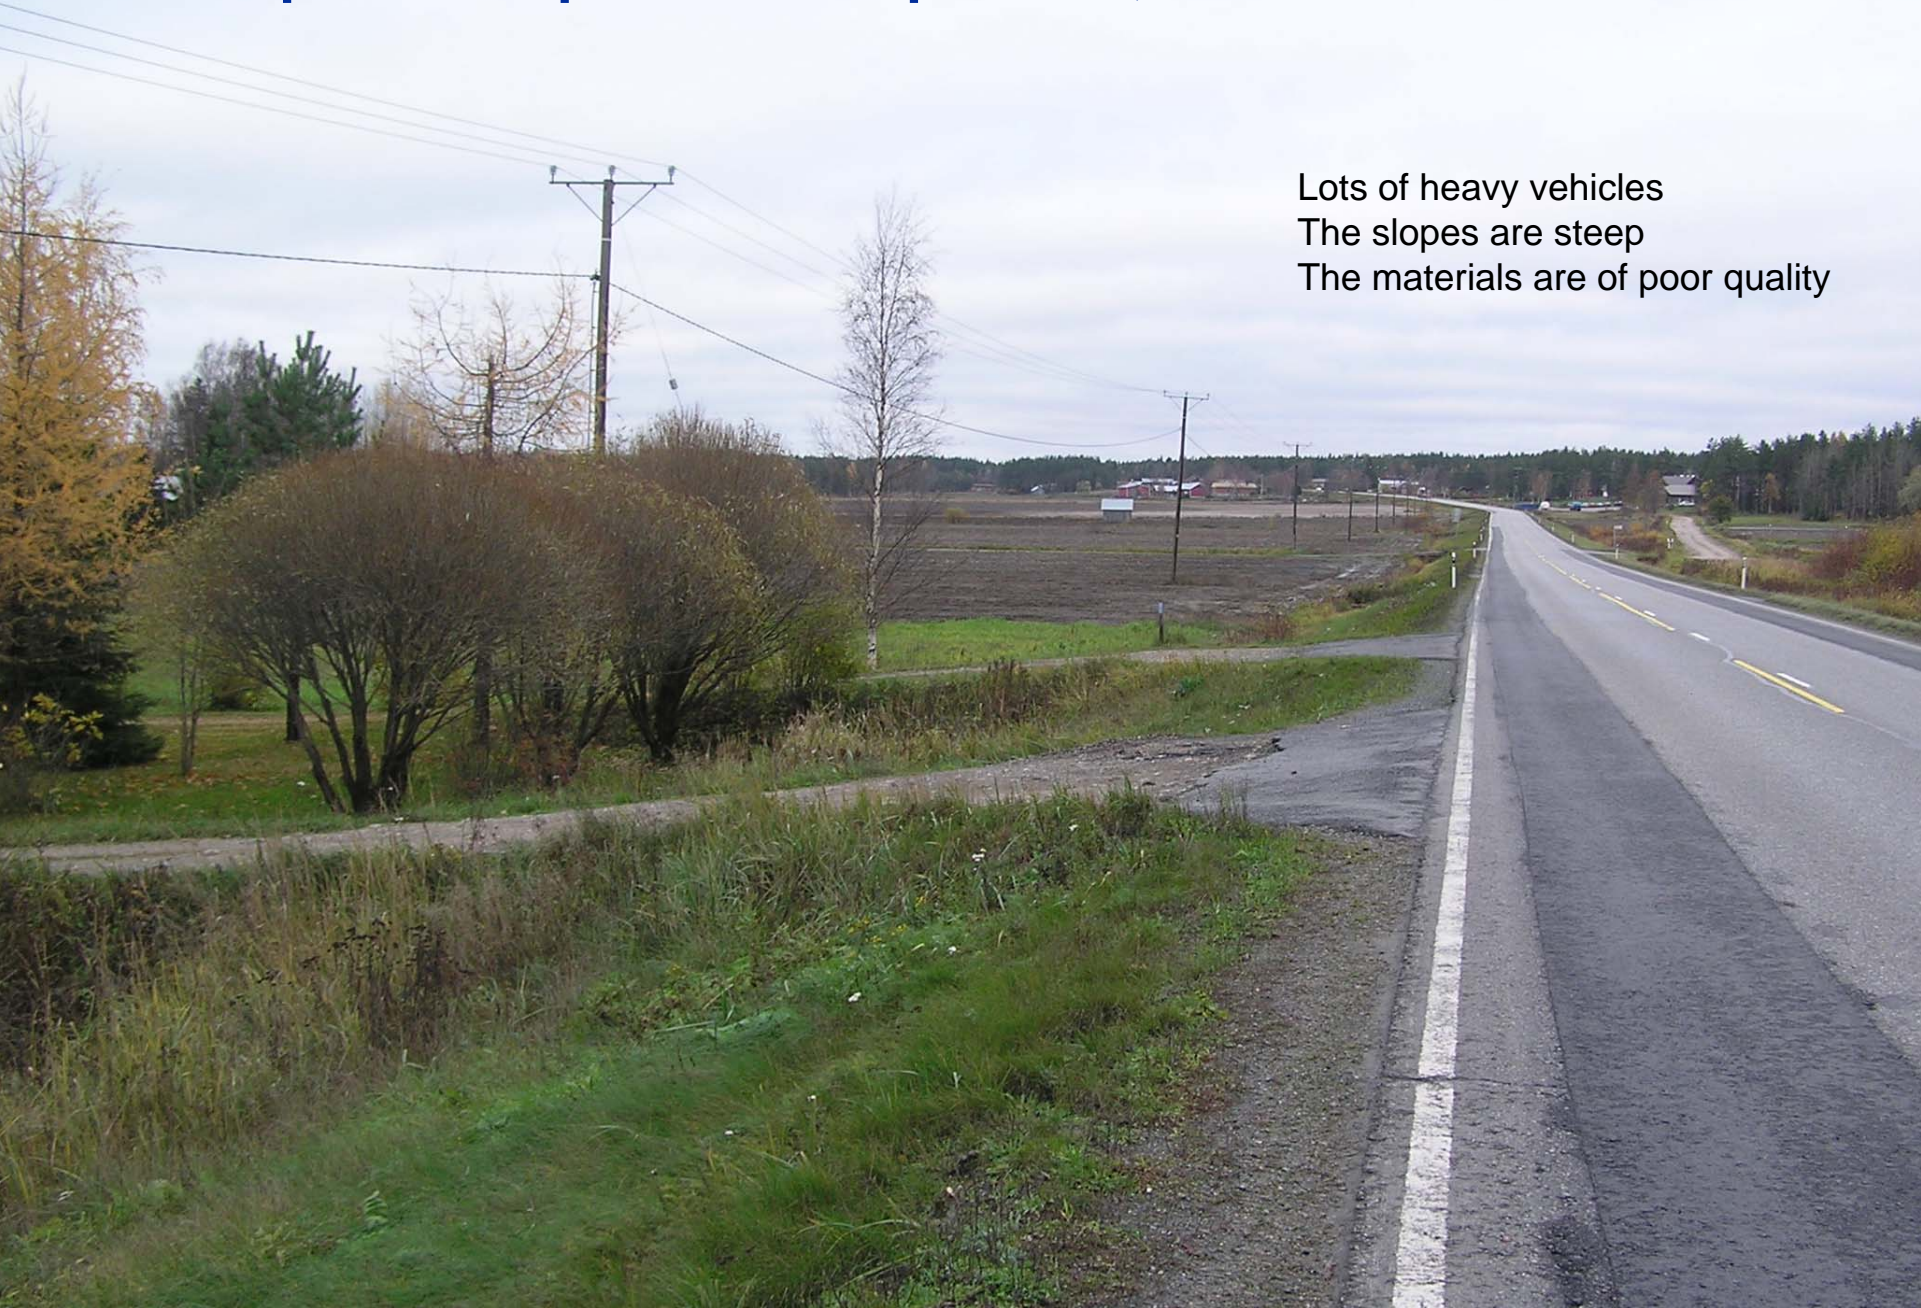
Lots of heavy vehicles  
The slopes are steep  
The materials are of poor quality

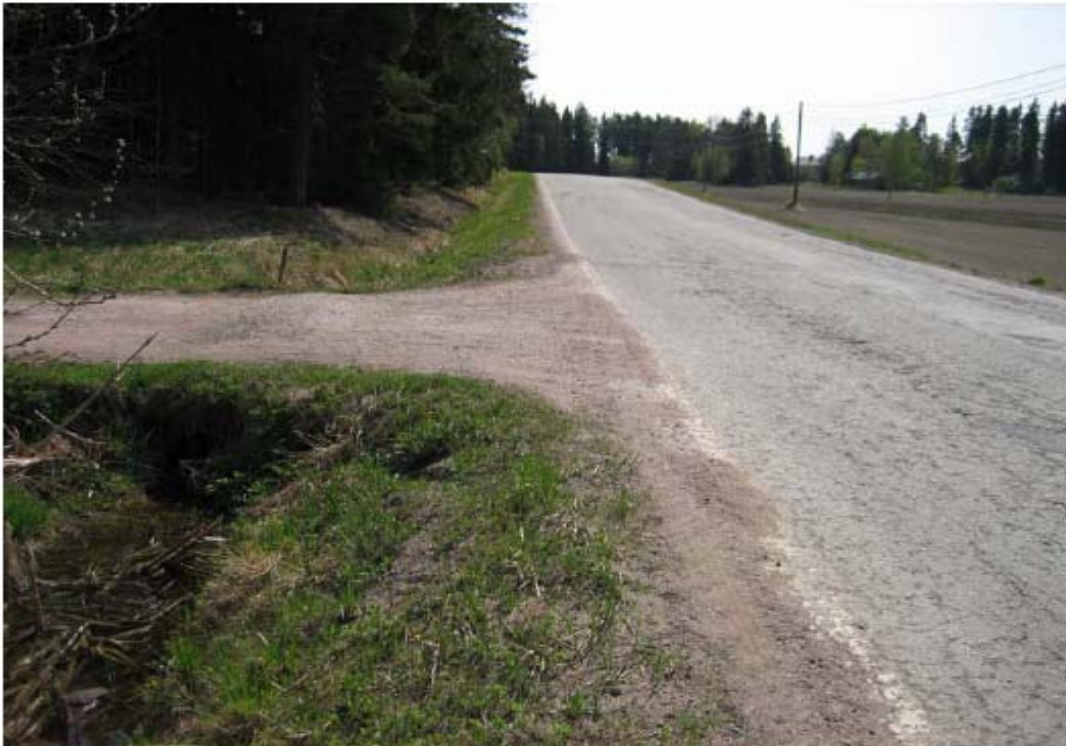
## An example of the problems in practice, 5: how much does the new culvert improve the condition state?

Kuva 2 . Pl 2510 ympäristö: Sivutierumpu routunut ja noussut, vesi ei pääse päätierummulle + lisäksi päätierumpu on tukossa. Tiessä näkyvissä kohteelle tyypillinen vanha, reikiintynyt päällyste.
