MODELING GRAVEL ROAD DETERIORATION

Ms. Anne Valkonen, M.Sc (Civil Eng.) Research Scientist
Tampere University of Technology
P.O.Box 600, FIN-33101 Tampere, FINLAND
E-mail: Anne.Valkonen@tut.fi, fax +358 3 31152884

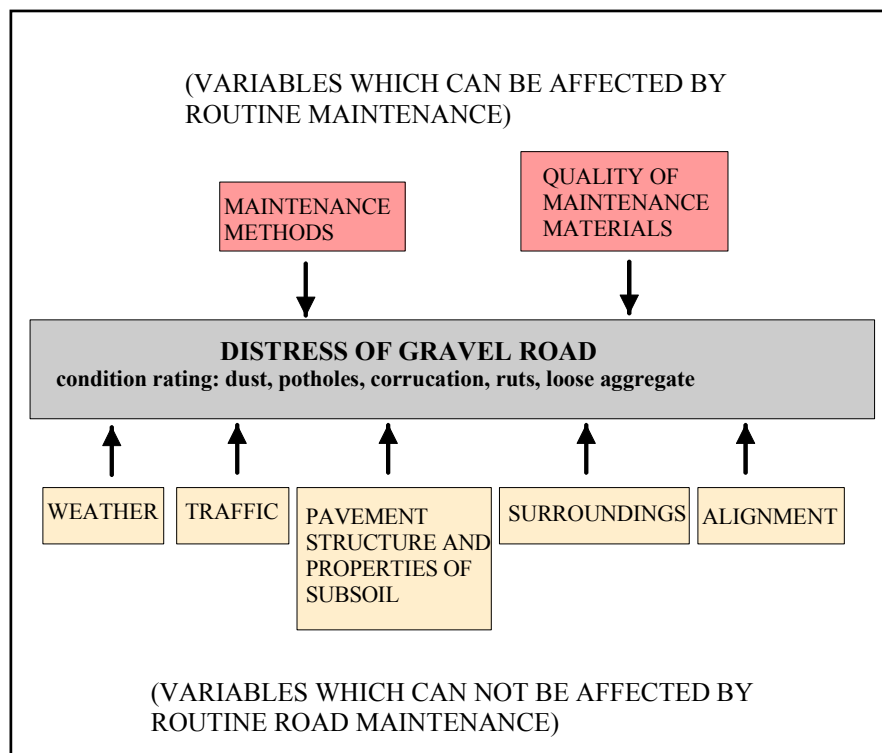
Figure 1: Variable groups assessed in this study

Most of the previous gravel road research that has been conducted has focused primarily on maintenance materials and dust binding methods. Few studies have examined effects of surroundings, weather or subsoil although they all are assumed to be relevant factors when evaluating gravel road deterioration. This is probably because those factors can not be affected by routine maintenance. The aim of this study is to find out the most significant variables affecting the gravel road deterioration and especially the most important properties of the maintenance aggregate concerning gravel road surface quality. The variable groups assessed are shown in Fig 1.

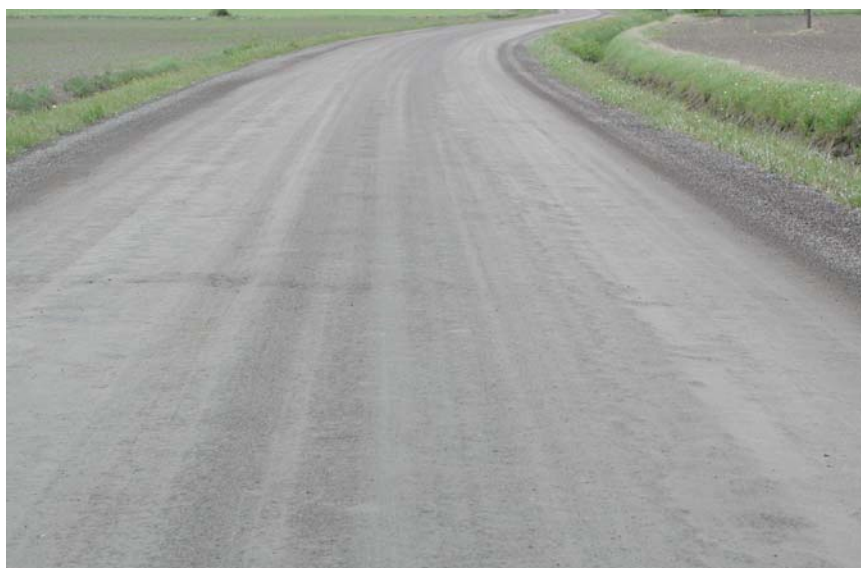
Figure 2: Surface condition of firm and well performed test road in July 2001

All the data collected is not assessed thus far. The project will be finished in 2004 and the final results are then published. However, after the first year experience we assume that it is possible to achieve good surface condition of gravel road although the roadside area is open, ADT is quite high and weather is dry. Usually if the road is in shadow the surface is firm, some potholes may still occur, but if there is no shadow of trees and the weather is fine, loose aggregate and dust are typically seen on the road and road side area. There was however one exception in our test road network. Although surrounded by fields, this particular road surface showed a proper behaviour. This successful behaviour is assumed to be due to suitable materials and not of favourable surroundings
